**Figure 2.1-1**  
Portland Harbor RI/FS  
Remedial Investigation Report  
Number of Observations of Radio-Tagged Chinook Salmon in  
Shallow Water and Deep Water Habitats between RM 3.5 and 11.7

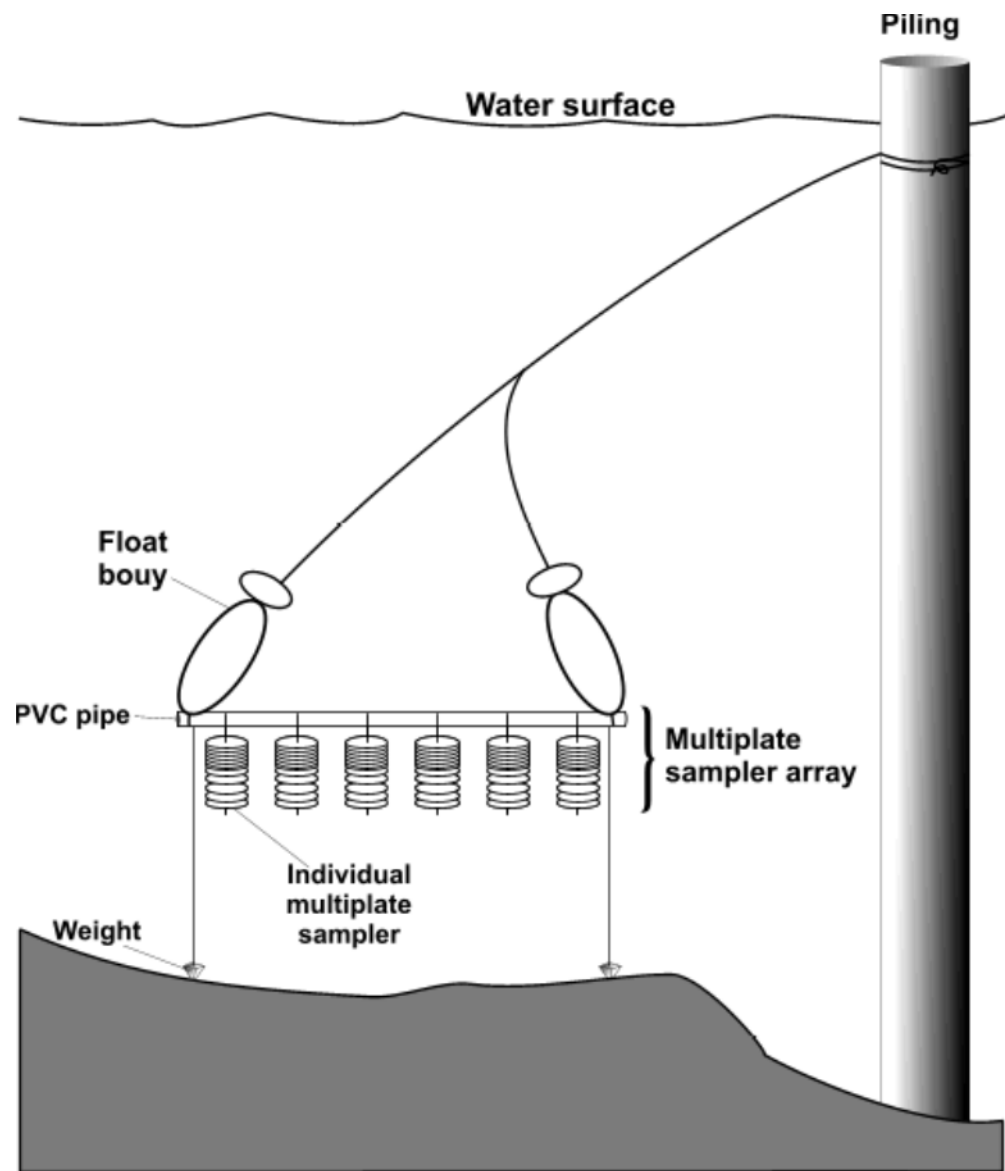
**Figure 2.1-2**  
Portland Harbor RI/FS  
Remedial Investigation Report  
Multiplate Sampler Array

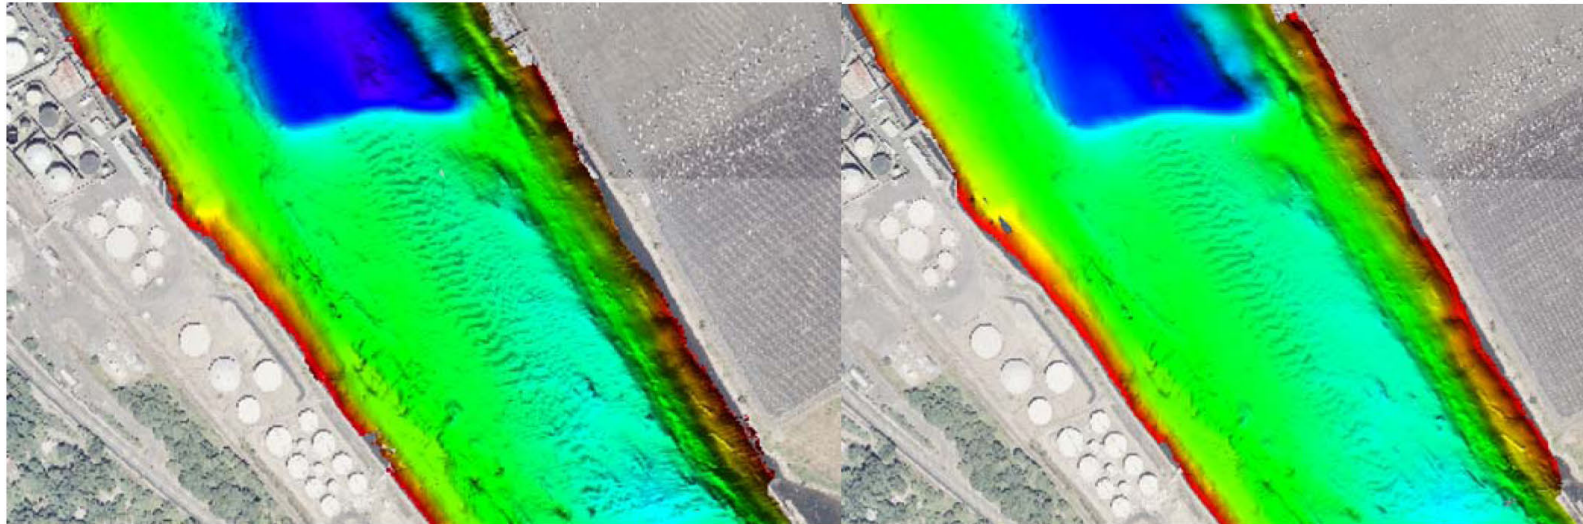
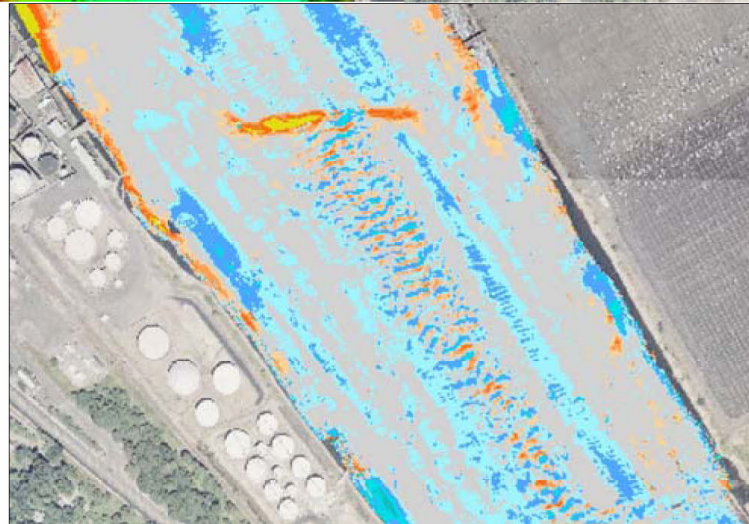
Winter 2002

Summer 2002

Difference Analysis

**Figure 2.1-3**  
Portland Harbor RI/FS  
Remedial Investigation Report  
Example of Winter and Summer 2002 Sun-Illuminated  
Images and Difference Analysis (DEA 2003a)

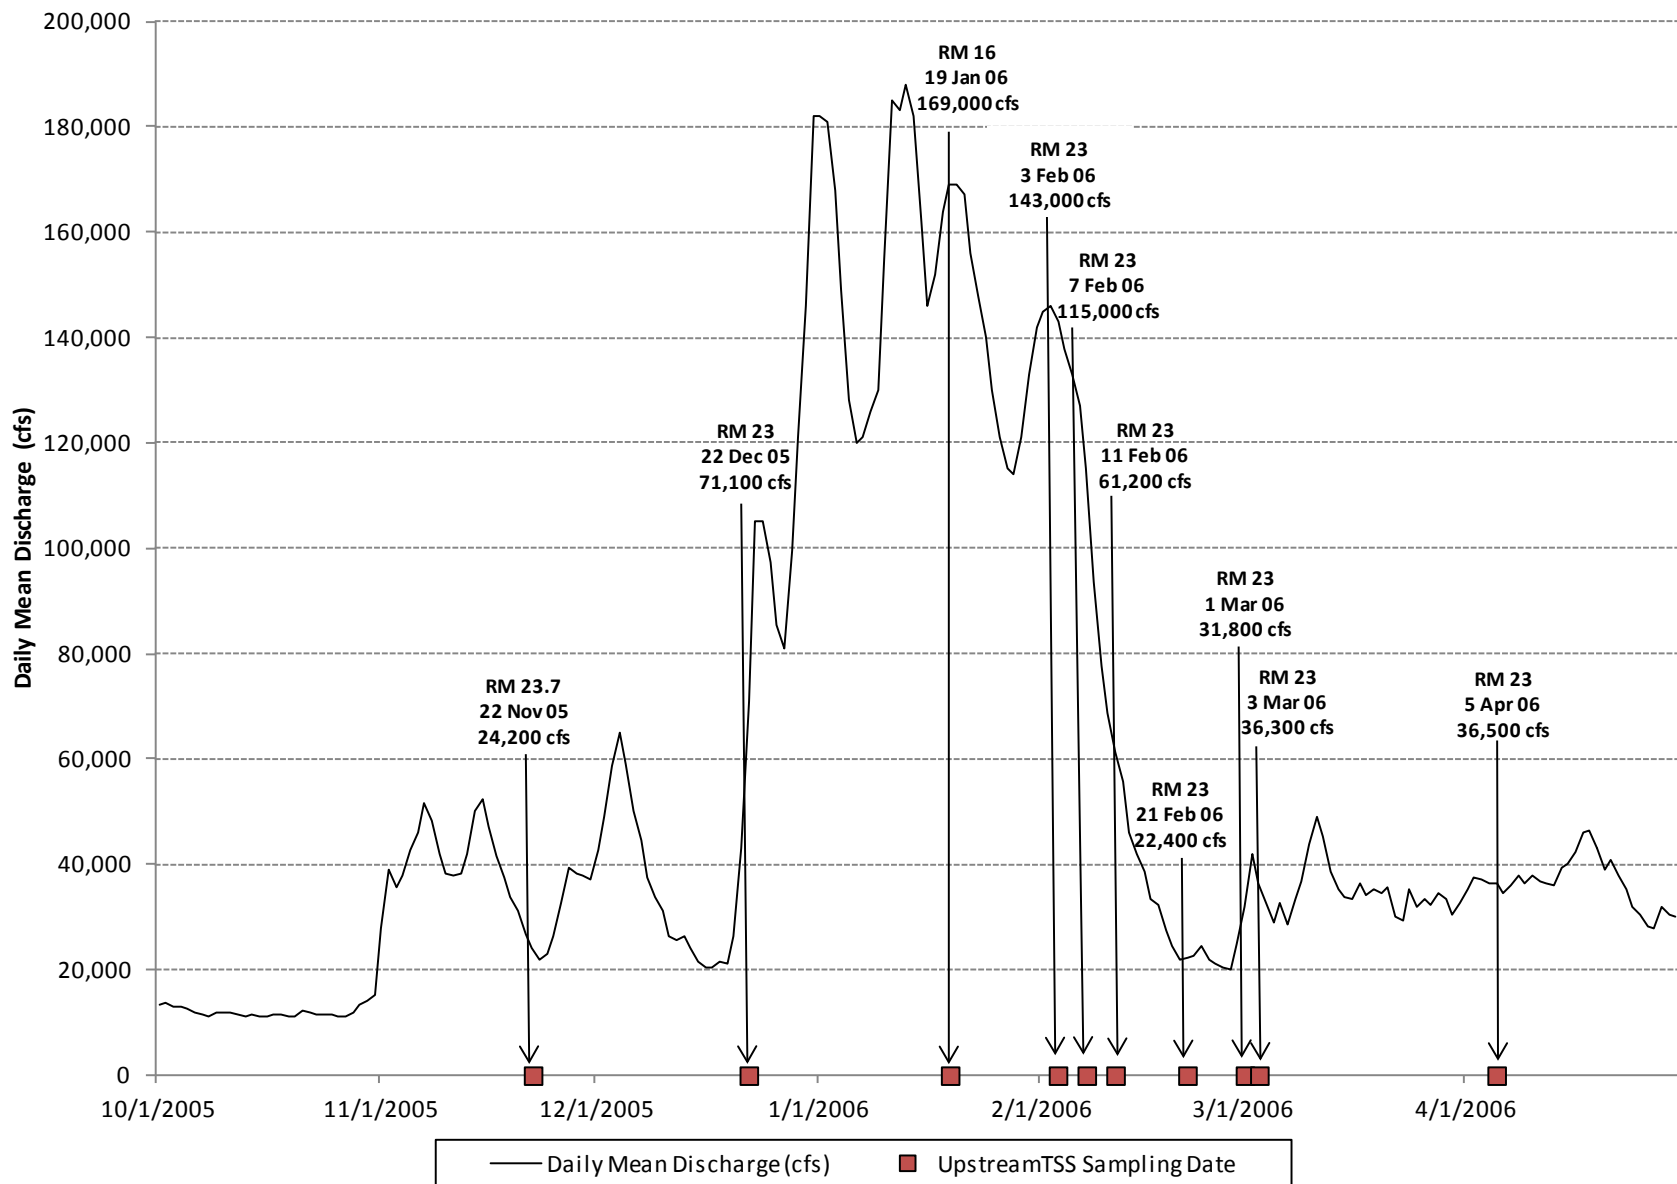
Note: Daily mean discharge values shown were downloaded from the USGS Real Time National Water Information System (NWIS) Database for the Morrison Bridge station 14211720 on March 6, 2009. Discharge values shown for October 1-31, December 16, February 24-27, and April 1-3 are estimated.

**Figure 2.1-4**  
 Portland Harbor RI/FS  
 Remedial Investigation Report  
 Upstream TSS Study Period Hydrograph and Sampling Dates

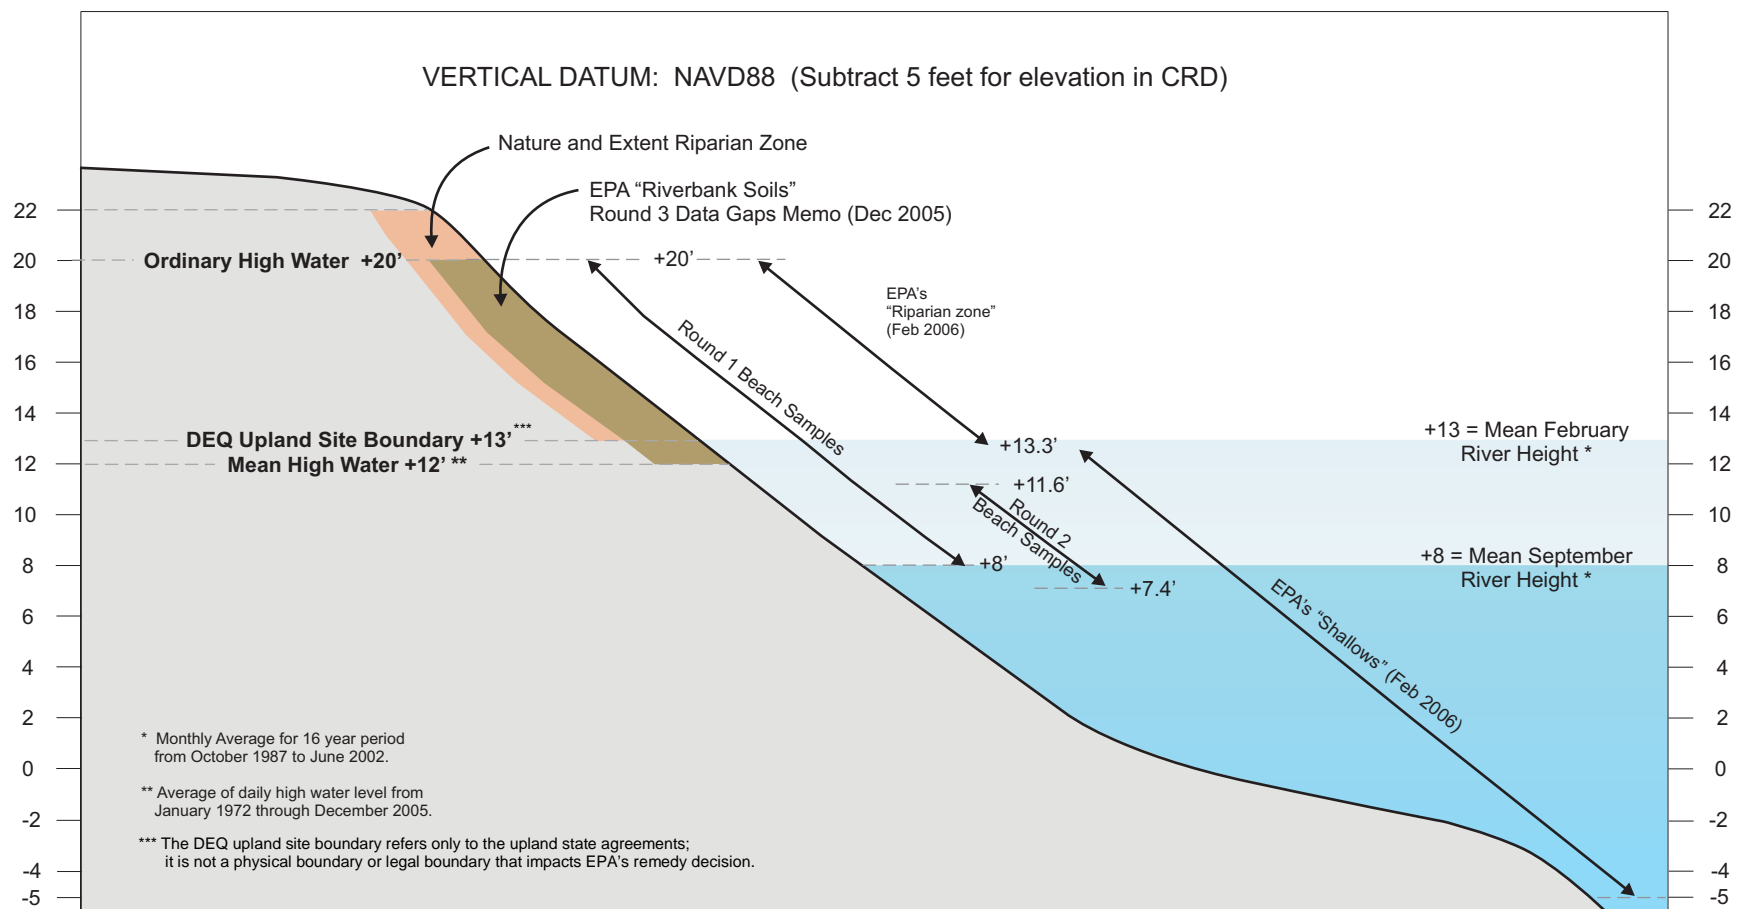
**Figure 2.2-1**  
 Portland Harbor RI/FS  
 Remedial Investigation Report  
 Schematic Willamette Riverbank  
 Cross Section, RM 2-11
